FLOWER OF SULFUR TEST REPORT

Customer Company : Apacer Technology Inc
Customer Address : No. 32, Zhongcheng Rd., Tucheng Dist., New Taipei City 236
, Taiwan (R.O.C.)
Laboratory Address : No.10-1, Lixing 1st Rd., East Dist., Hsinchu City 300
, Taiwan (R.O.C.)
Model Name : PX220-M280
Date Received : DEC 20, 2020
Date Tested : DEC 28, 2020 ~ JAN 6, 2021

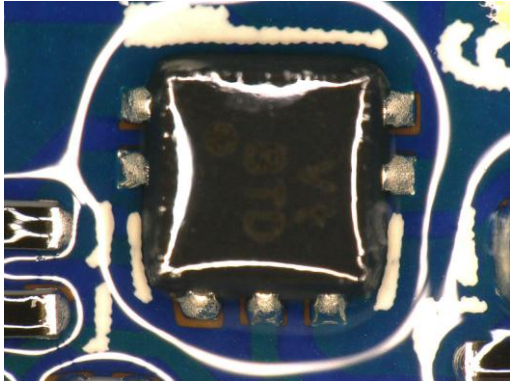
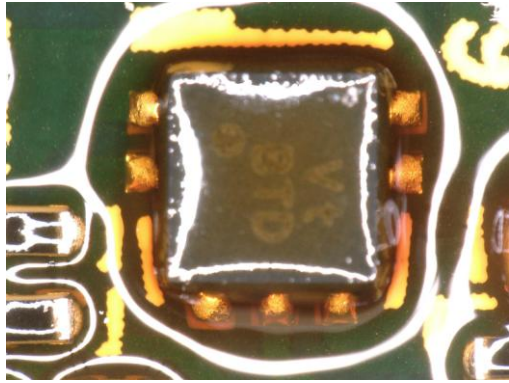
Location	Before Test (Day0)	After Test (Day8)
TV#01_01

Results	No Corrosion	No Corrosion
TV#01_02

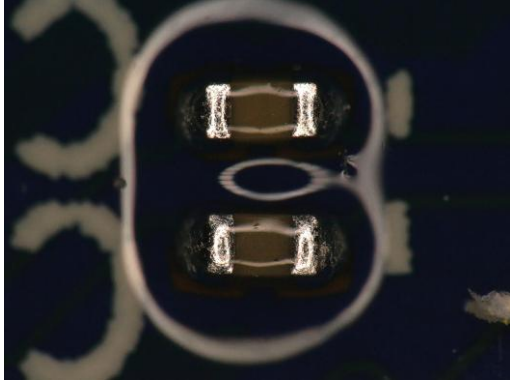
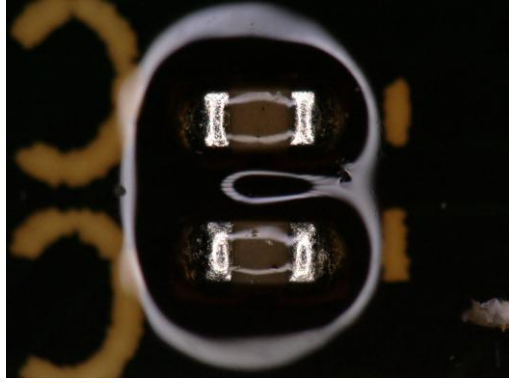
Results	No Corrosion	No Corrosion
TV#01_03

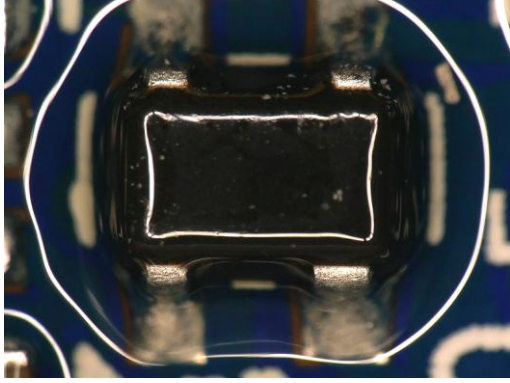
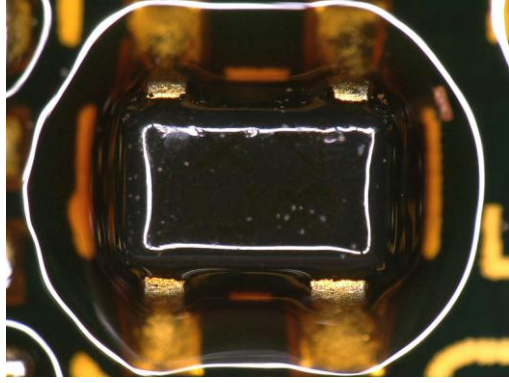
Results	No Corrosion	Leadframe Pitting/Pore Corrosion

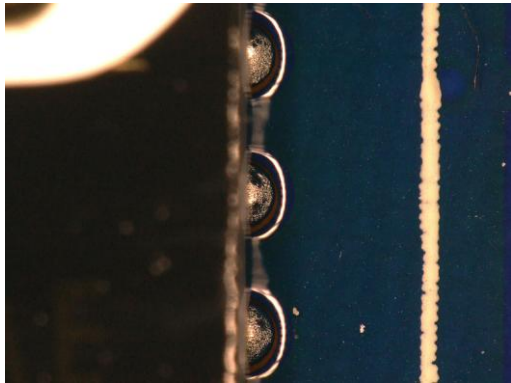
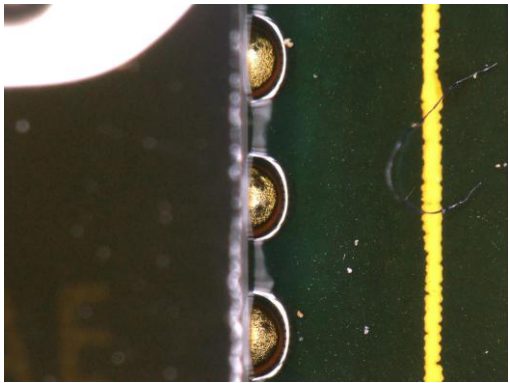
Location	Before Test (Day0)	After Test (Day8)
TV#01_10

Results	No Corrosion	No Corrosion

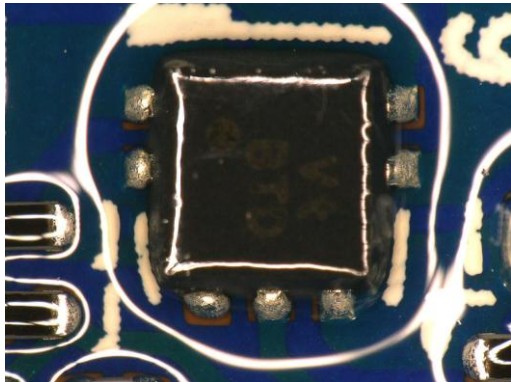
Location	Before Test (Day0)	After Test (Day8)
TV#02_01

Results	No Corrosion	No Corrosion

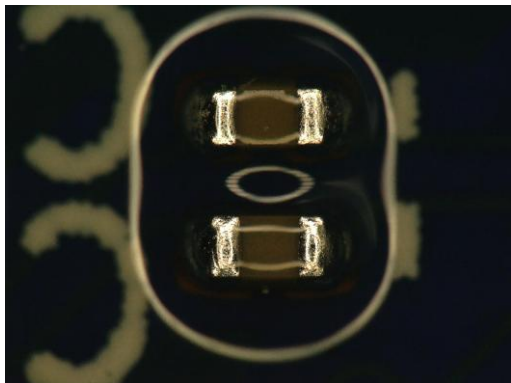
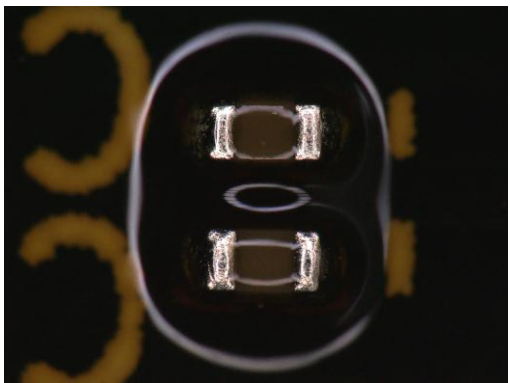
TV#02_02

Results	No Corrosion	No Corrosion

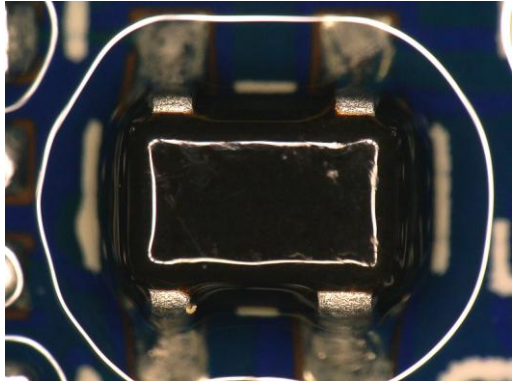
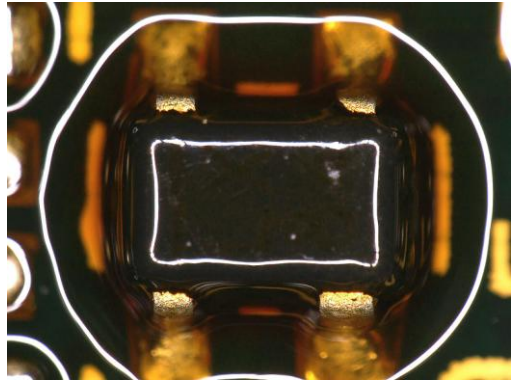
Location	Before Test (Day0)	After Test (Day8)
TV#02_03

Results	No Corrosion	Leadframe Pitting/Pore Corrosion
TV#02_04

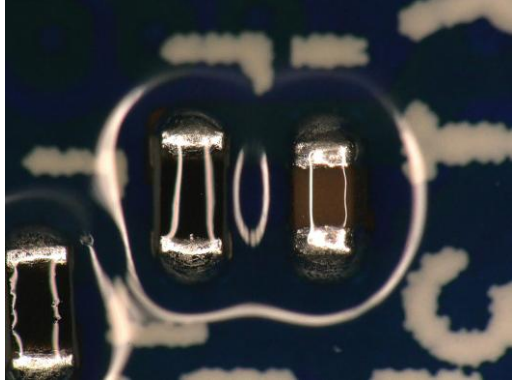
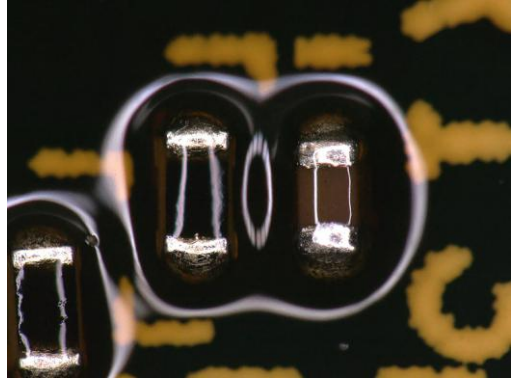
Results	No Corrosion	No Corrosion
TV#02_05

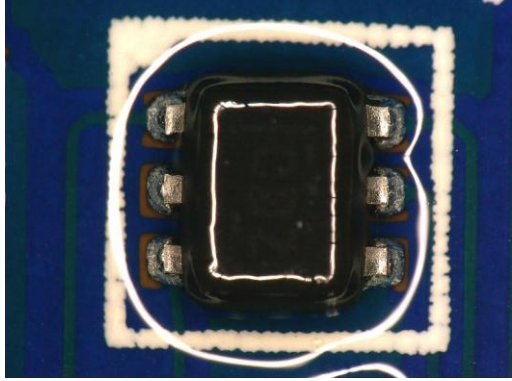
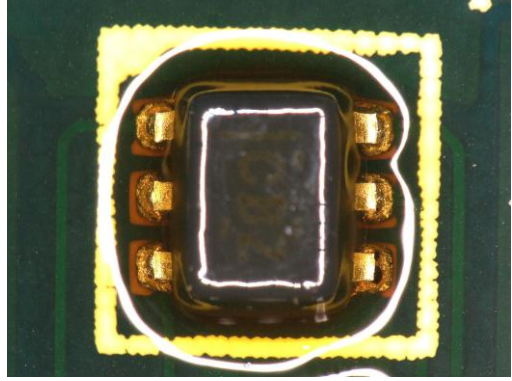
Results	No Corrosion	Leadframe Pitting/Pore Corrosion

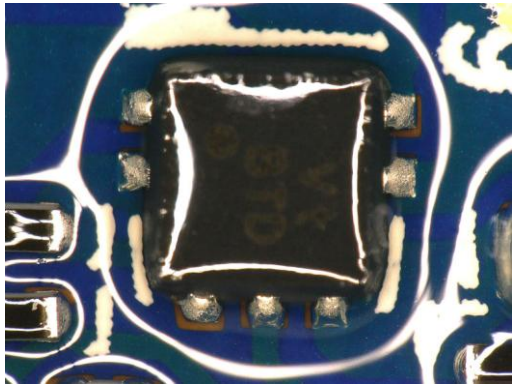
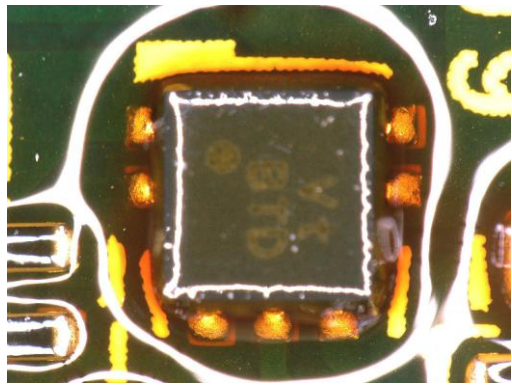
Location	Before Test (Day0)	After Test (Day8)
TV#04_01

Results	No Corrosion	No Corrosion
TV#04_02

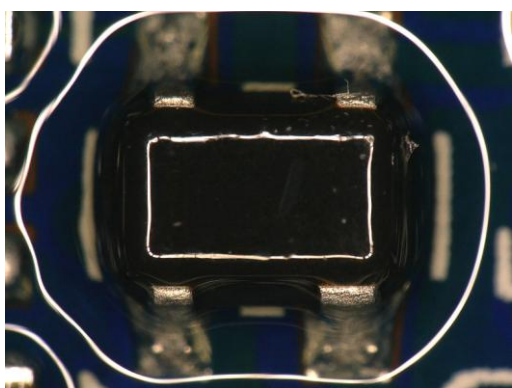
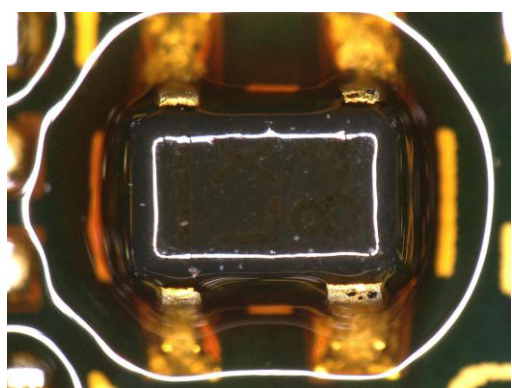
Results	No Corrosion	No Corrosion
TV#04_03

Results	No Corrosion	Leadframe Pitting/Pore Corrosion

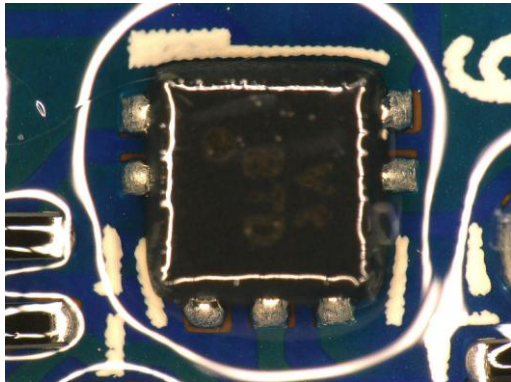
Location	Before Test (Day0)	After Test (Day8)
TV#05_01

Results	No Corrosion	Leadframe Pitting/Pore Corrosion
TV#05_02

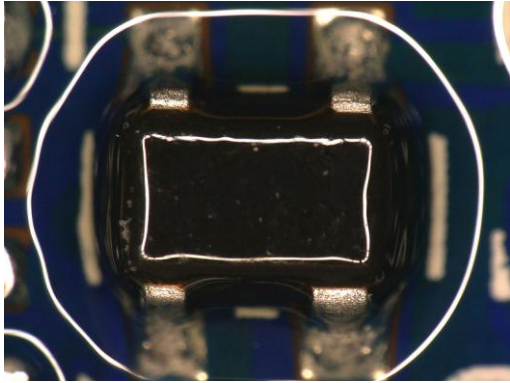
Location	Before Test (Day0)	After Test (Day8)
TV#05_03

Results	No Corrosion	Leadframe Pitting/Pore Corrosion
TV#05_04

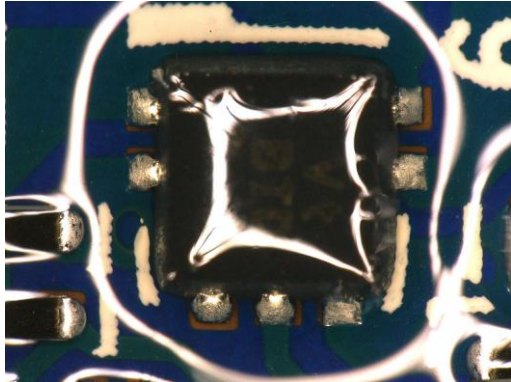
Location	Before Test (Day0)	After Test (Day8)
TV#06_01

Results	No Corrosion	Leadframe Pitting/Pore Corrosion

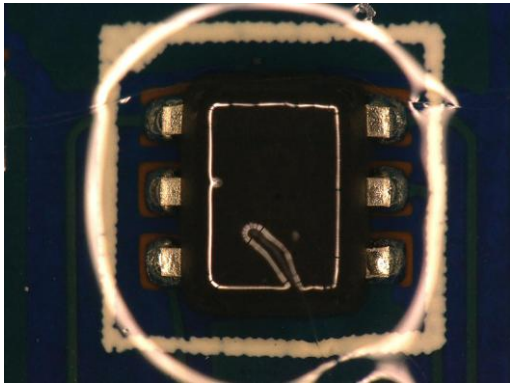
Location	Before Test (Day0)	After Test (Day8)
TV#06_05

Results	No Corrosion	Leadframe Pitting/Pore Corrosion
TV#06_06

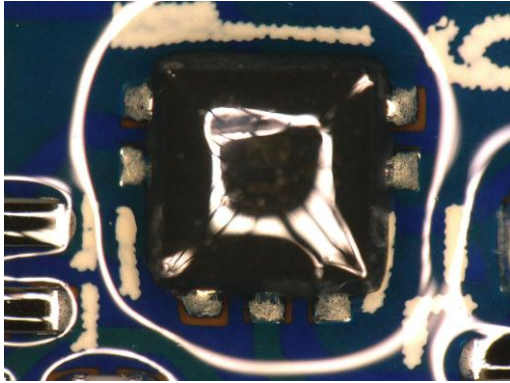
Location	Before Test (Day0)	After Test (Day8)
TV#07_01

Results	No Corrosion	Leadframe Pitting/Pore Corrosion
TV#07_02

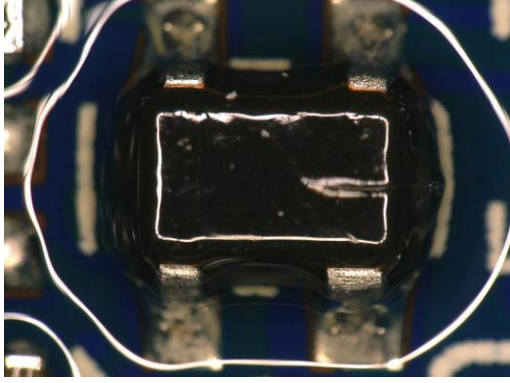
Results	No Corrosion	No Corrosion
TV#07_03

Results	No Corrosion	Leadframe Pitting/Pore Corrosion

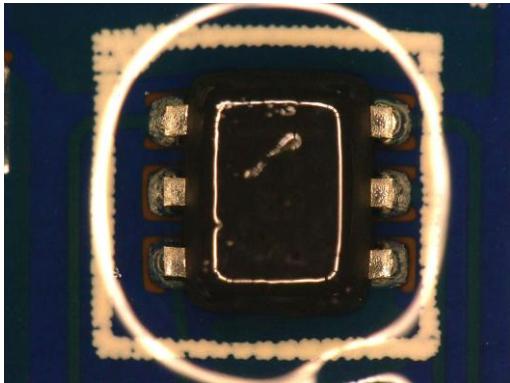
Results	No Corrosion	No Corrosion
TV#07_05

Results	No Corrosion	Leadframe Pitting/Pore Corrosion
TV#07_06

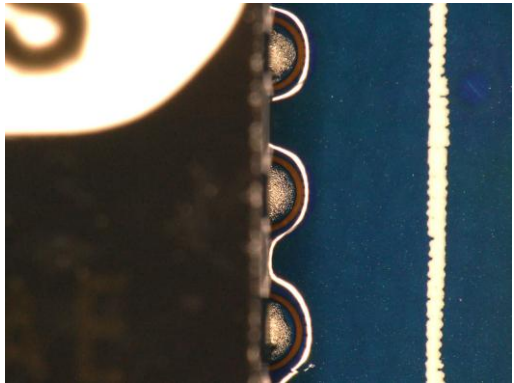
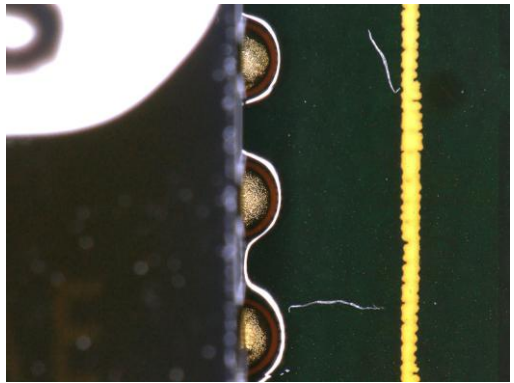
Location	Before Test (Day0)	After Test (Day8)
TV#07_10

Results	No Corrosion	No Corrosion
