FLOWER OF SULFUR TEST REPORT

Customer Company : Apacer Technology Inc
 Customer Address : No. 32, Zhongcheng Rd., Tucheng Dist., New Taipei City 236
, Taiwan (R.O.C.)
 Laboratory Address : No.10-1, Lixing 1st Rd., East Dist., Hsinchu City 300
, Taiwan (R.O.C.)
 Model Name : SX250-M280
 Date Received : DEC 20, 2020
 Date Tested : DEC 28, 2020 ~ JAN 6, 2021

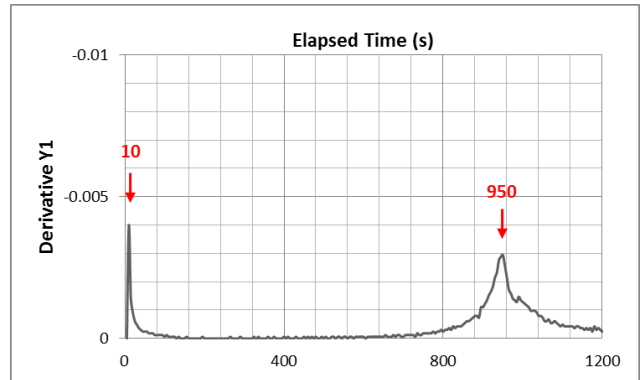
Reduction Curve

Silver Corrosion Product	Seconds	Thickness, angstroms	Exposure Days	Silver Corrosion Rate, angstroms/day
AgCl	0	0	1	8244
Ag ₂ S	940	8244

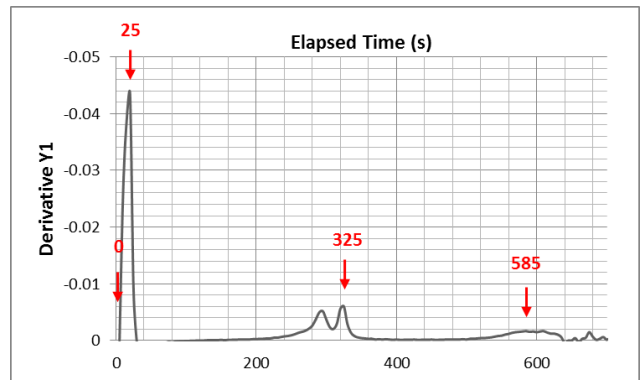
Reduction Curve

Copper Corrosion Product	Seconds	Thickness, angstroms	Exposure Days	Copper Corrosion Rate, angstroms/day
Cu ₂ O	25	618	1	12142
CuO	300	3864		
Cu ₂ S	260	7660

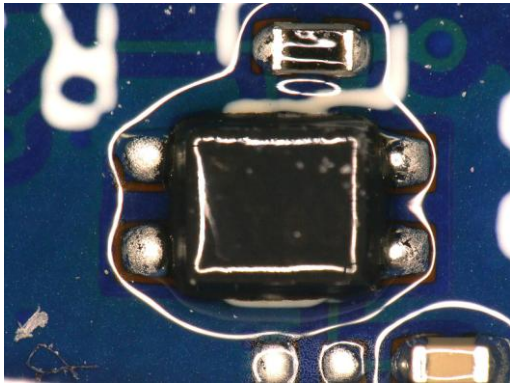
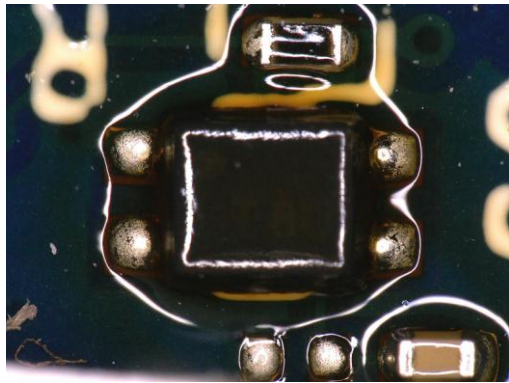
Location	Before Test (Day0)	After Test (Day8)
TV#01_04

Results	No Corrosion	Leadframe Pitting/Pore Corrosion
TV#01_05

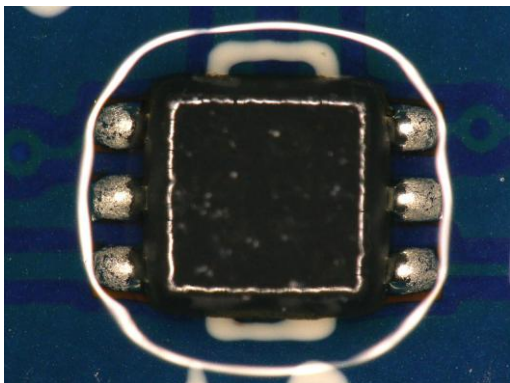
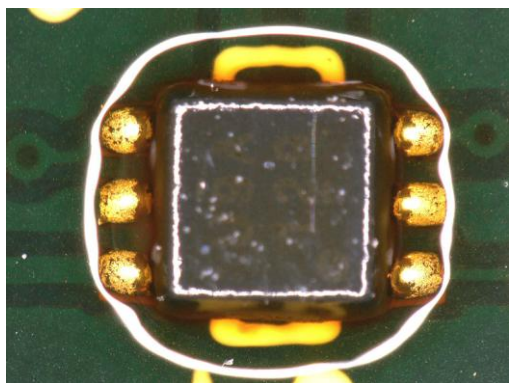
Results	No Corrosion	Leadframe Pitting/Pore Corrosion

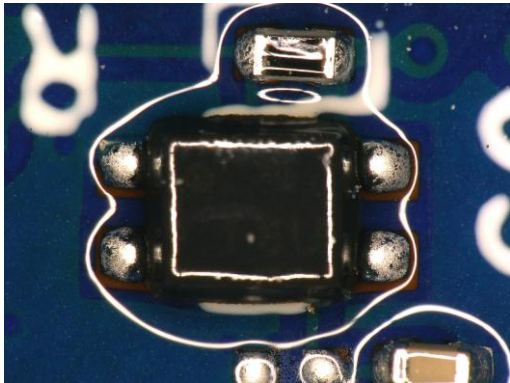
Results	No Corrosion	Leadframe Pitting/Pore Corrosion
TV#02_05

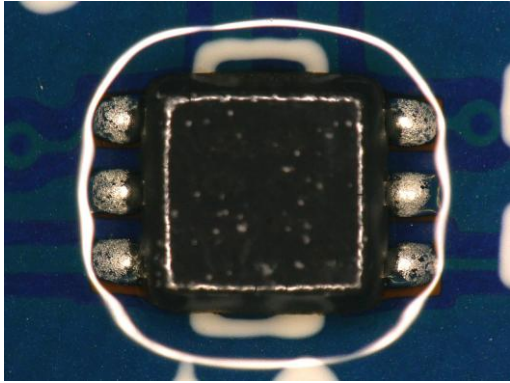
Location	Before Test (Day0)	After Test (Day8)
TV#02_06

Results	No Corrosion	Leadframe Pitting/Pore Corrosion
TV#02_07

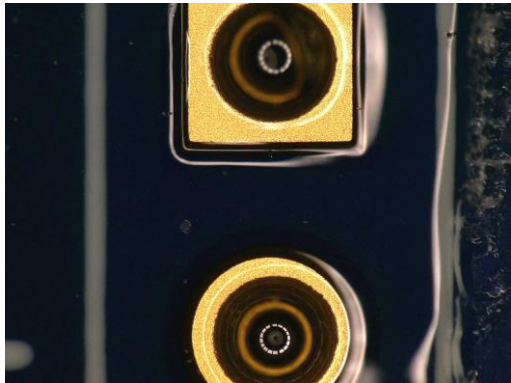
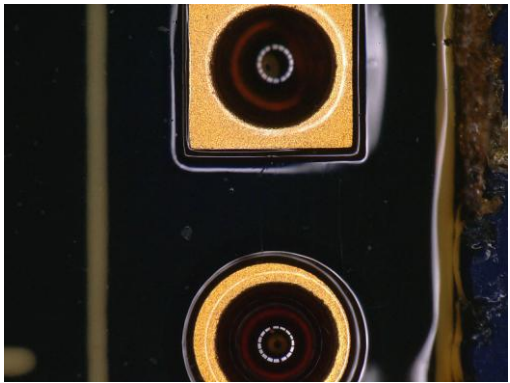
Location	Before Test (Day0)	After Test (Day8)
TV#02_09

Results	No Corrosion	Slight Pitting/Pore Corrosion
TV#02_10

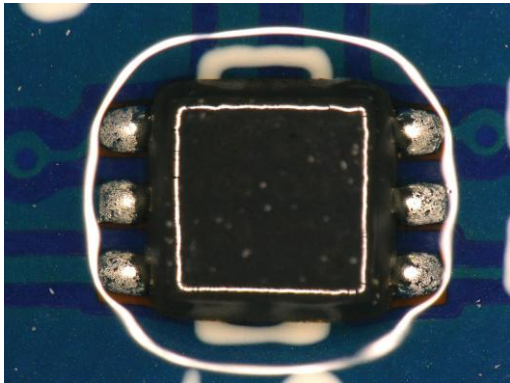
Results	No Corrosion	Leadframe Pitting/Pore Corrosion
TV#03_07

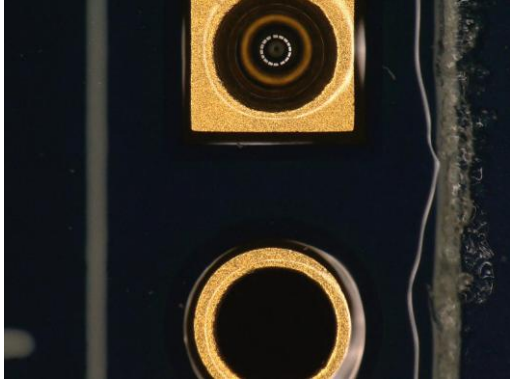
Results	No Corrosion	Slight Pitting/Pore Corrosion
TV#03_10

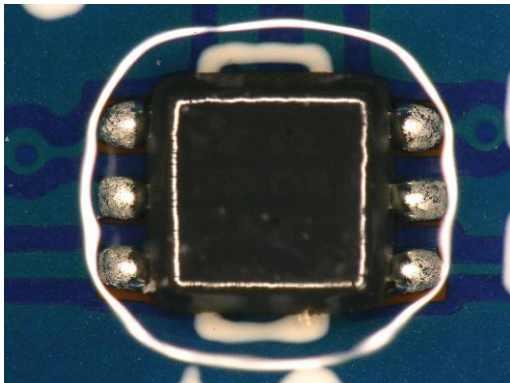
Results	No Corrosion	Leadframe Pitting/Pore Corrosion

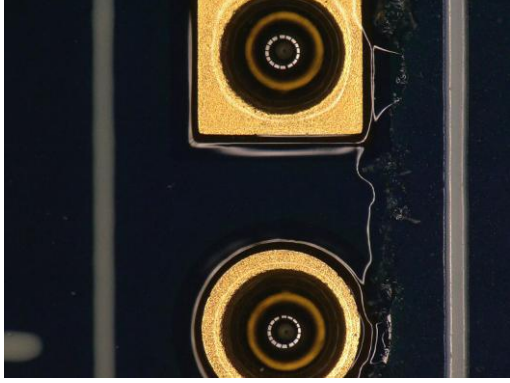
Results	No Corrosion	Slight Pitting/Pore Corrosion

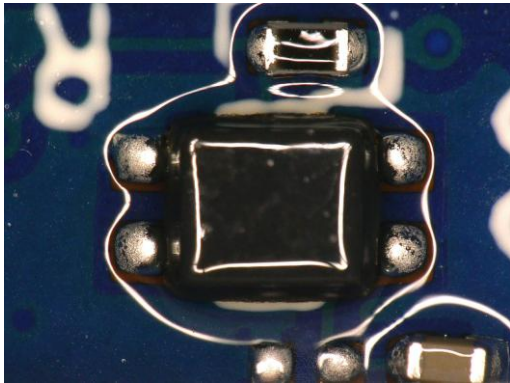
Results	No Corrosion	Leadframe Pitting/Pore Corrosion
TV#05_05

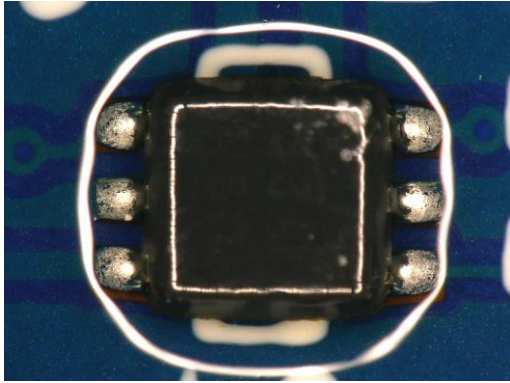
Location	Before Test (Day0)	After Test (Day8)
TV#05_06

Results	No Corrosion	Leadframe Pitting/Pore Corrosion
TV#05_07

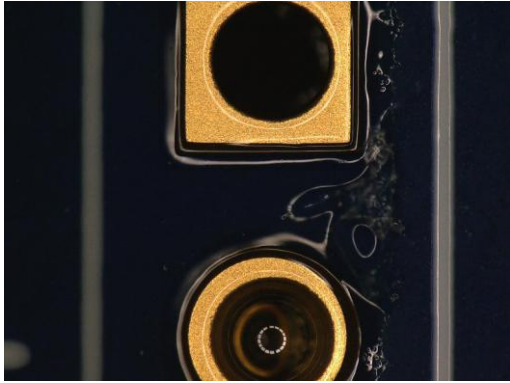
Location	Before Test (Day0)	After Test (Day8)
TV#05_09

Results	No Corrosion	Slight Pitting/Pore Corrosion
TV#05_10

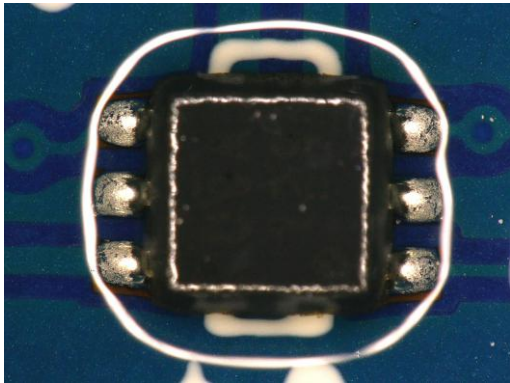
Results	No Corrosion	Leadframe Pitting/Pore Corrosion
TV#06_07

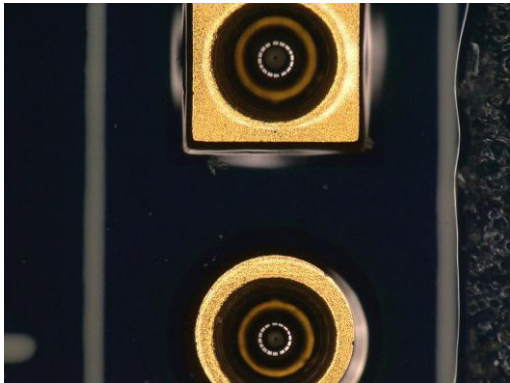
Results	No Corrosion	Pitting/Pore Corrosion
TV#06_10

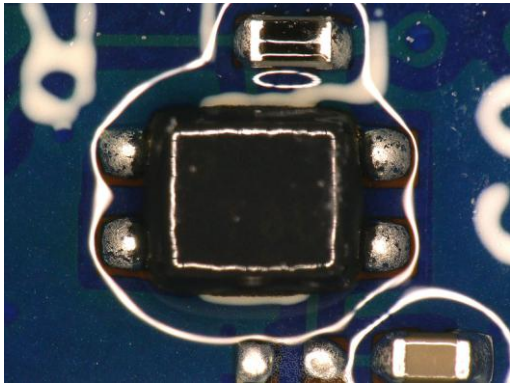
Location	Before Test (Day0)	After Test (Day8)
TV#07_04

Results	No Corrosion	Leadframe Pitting/Pore Corrosion
TV#07_05

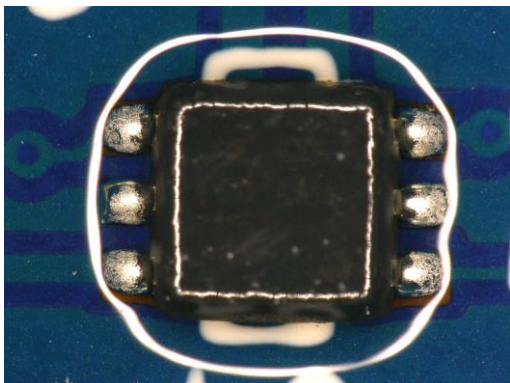
Results	No Corrosion	Leadframe Pitting/Pore Corrosion
