Apacer Technology Inc. **Qual Report**

PX25E-M280
Environment Test Report

Test Start : 2023,5,25
Test End : 2023,6,29

Ver 1.1

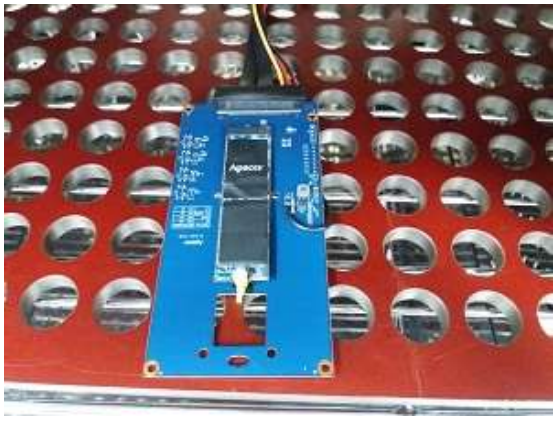
1.10 Testing Photo

Testing Condition	Temperature	Testing Time	Result	Remark
			Sample No. 1	
Operation	0°C	96 hours	Pass	-

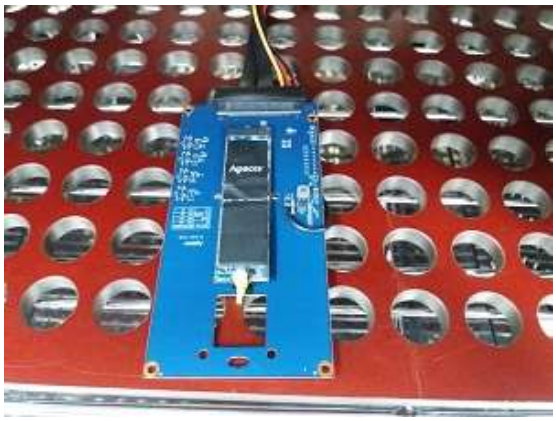
2.10 Testing Photo

Testing Condition	Temperature/Humidity	Testing Time	Result	Remark
			Sample No. 1	
Operation	70ºC/50~95%RH	96 hours	Pass	-

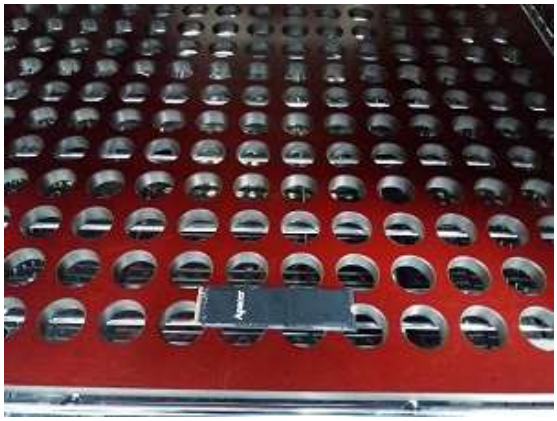
3.10 Testing Photo

Testing Condition	Temperature	Testing Time	Result	Remark
			Sample No. 1	
Non-Operation	-55ºC	96 hours	Pass	-
