TESTING / INSPECTION REPORT

REPORT NO : TT-100408-2

COMPANY : Apacer Technology Inc.
ADDRESS : 9F, 100, Sec.1, Hsin Tai Wu Rd.,
Hsichih Taipei Hsien 221, Taiwan, R.O.C.
TEL : 886-2-2696-1666
FAX : 886-2-2696-1668
SPECIMEN : ADMIII 44P/180D LP without dot board
DATE OF RECEIVED : 2010/03/05
DATE OF TESTED : 2010/03/29

TEST / INSPECTION ITEMS : Temperature Test

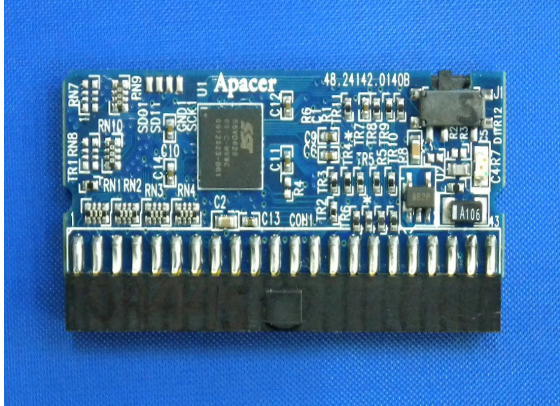
Testing photos	
Sample 1-1	Sample 1-2

Describe	PASS	FAIL	Non-Judgment
Function judgment	√	---	---
Appearance check	√	---	---

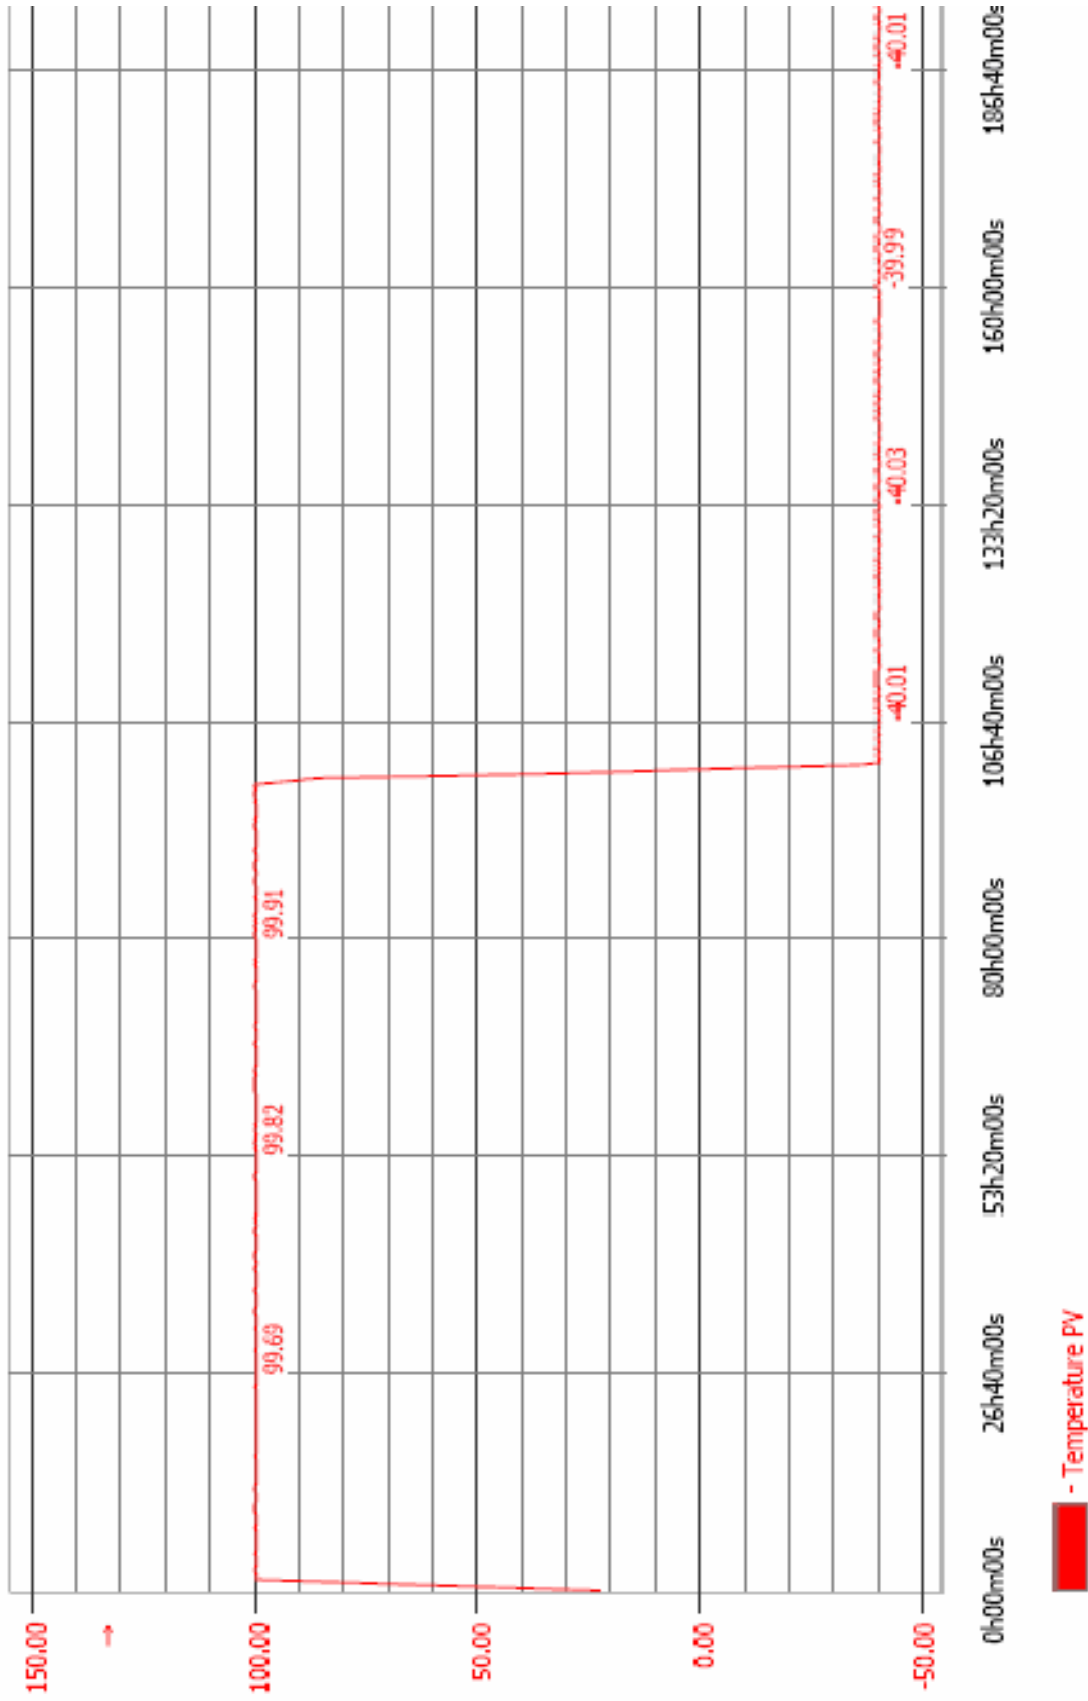
Temperature Test (Non-Operation)

Step	Temperature (°C)	Duration
1	100	96 hrs
2	-40	96 hrs

Test Cycle : 1 cycle
Total Test Time : 192 hrs
