TEST REPORT

Report No.: HC80062/2023

APACER TECHNOLOGY INC.

Product Description: PCIe M.2 2280
Style/ Item No.: PX25P-M280/ No.1
Quantity: Total 1 piece
Testing Period: Aug. 22, 2023 to Aug. 31, 2023

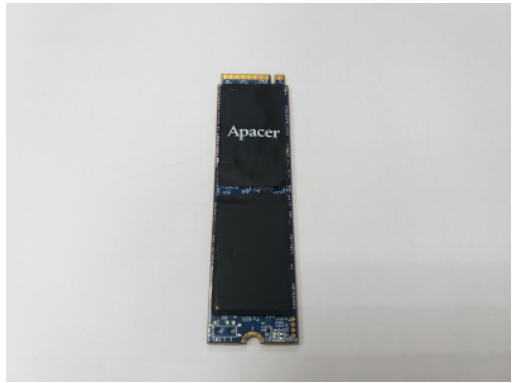
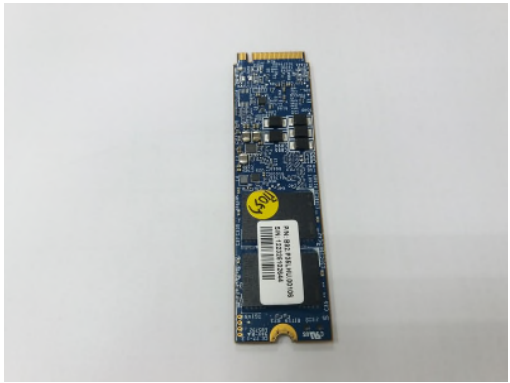
<p>1. Appearance of specimen</p>	<p>2. Appearance of specimen</p>

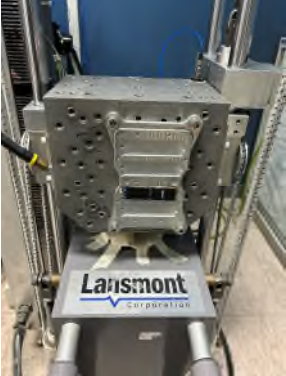
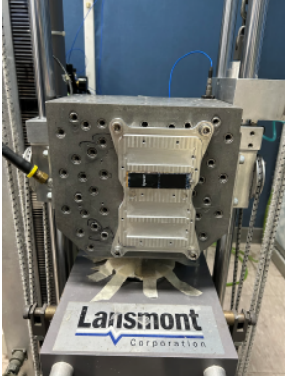
<p>3. Non-Operating Mechanical Shock Test (+X axis)</p>	<p>4. Non-Operating Mechanical Shock Test (-X axis)</p>

Shock direction: 6 faces ($\pm X, \pm Y, \pm Z$ axes, see photo 3 ~ 8)

Check Item	Appearance check (Visual check)	Functional check
Style/ Item No. PX25P-M280/ No.1	No visible damage	Normal

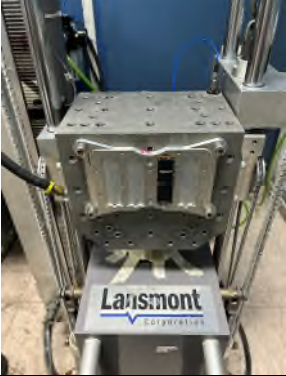
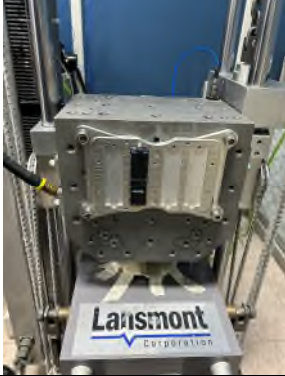
<p>5. Non-Operating Mechanical Shock Test (+Y axis)</p>	<p>6. Non-Operating Mechanical Shock Test (-Y axis)</p>
