## TESTING / INSPECTION REPORT

REPORT NO : VT-190708-1

COMPANY : Apacer Technology Inc.  
 ADDRESS : 1F., No.32, Zhongcheng Rd., Tucheng Dist.,  
 New Taipei City 236, Taiwan (R.O.C)  
 TEL : 886-2-2267-8000  
 FAX : 886-2-2267-2261  
 SPECIMEN : SATA Flash Drive  
 DATE OF RECEIVED : 2017/07/19  
 DATE OF TESTED : 2017/07/24

TEST / INSPECTION ITEMS : Vibration / Shock

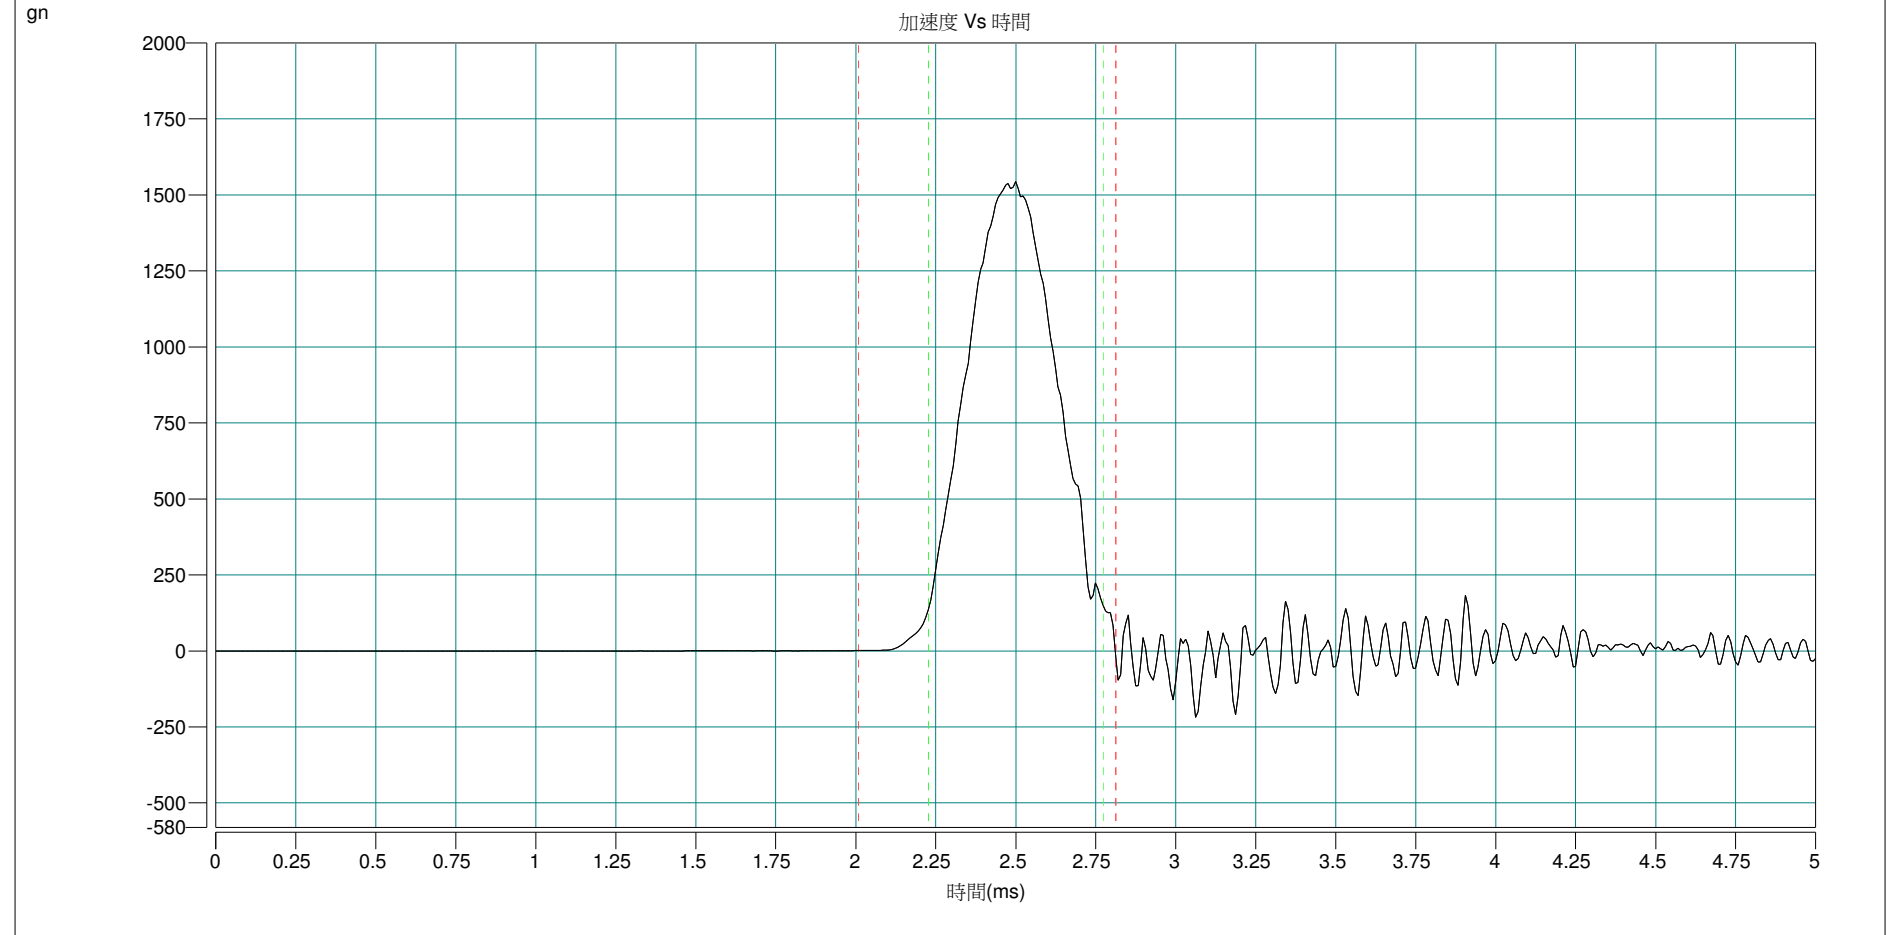
+Z axis

Signal	Acceleration (gn)	Duration (ms)	Velocity (In/s)	Filter (Hz)	Max Acc (gn)	Min Acc (gn)
Input1(t)	1544.73	0.54	197.45	2000.00	1544.73	-217.85
