## TESTING / INSPECTION REPORT

REPORT NO : VT-180510-3

SPECIMEN : SATA Flash Drive

TEST / INSPECTION ITEMS : Vibration / Shock

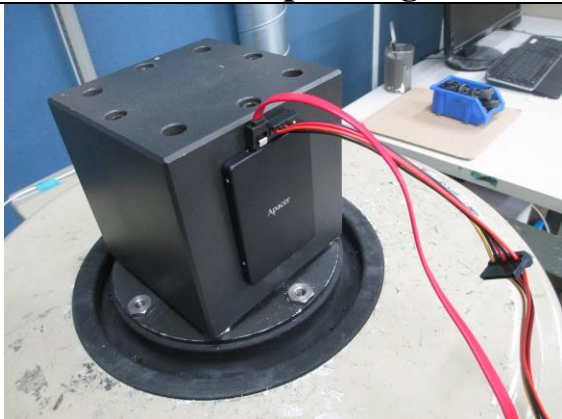
Vibration testing photos	
<b>X axis (Operating)</b>	<b>X axis (Non-Operating)</b>

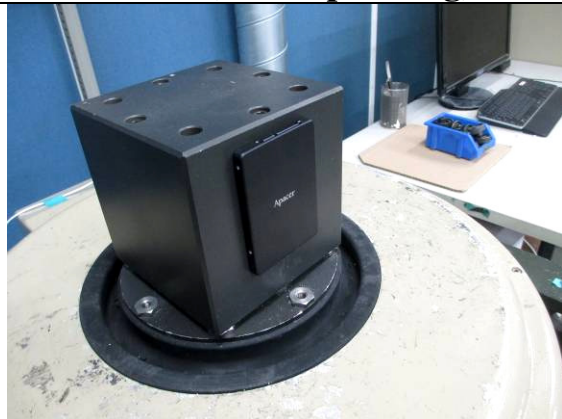
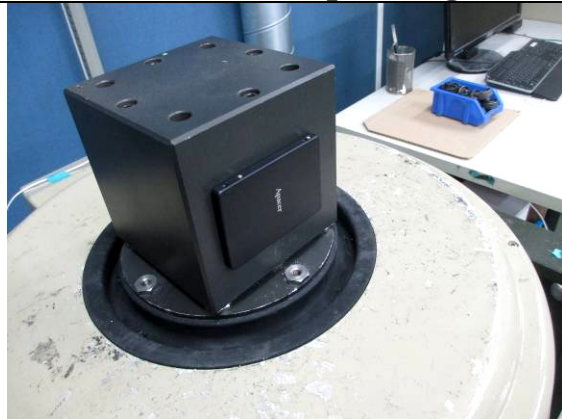
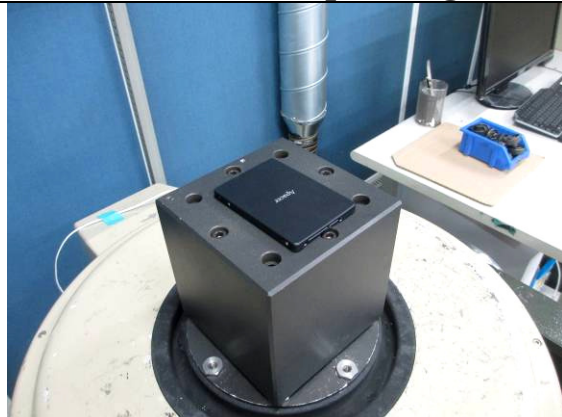
<b>Y axis (Operating)</b>	<b>Y axis (Non-Operating)</b>

<b>Z axis (Operating)</b>	<b>Z axis (Non-Operating)</b>

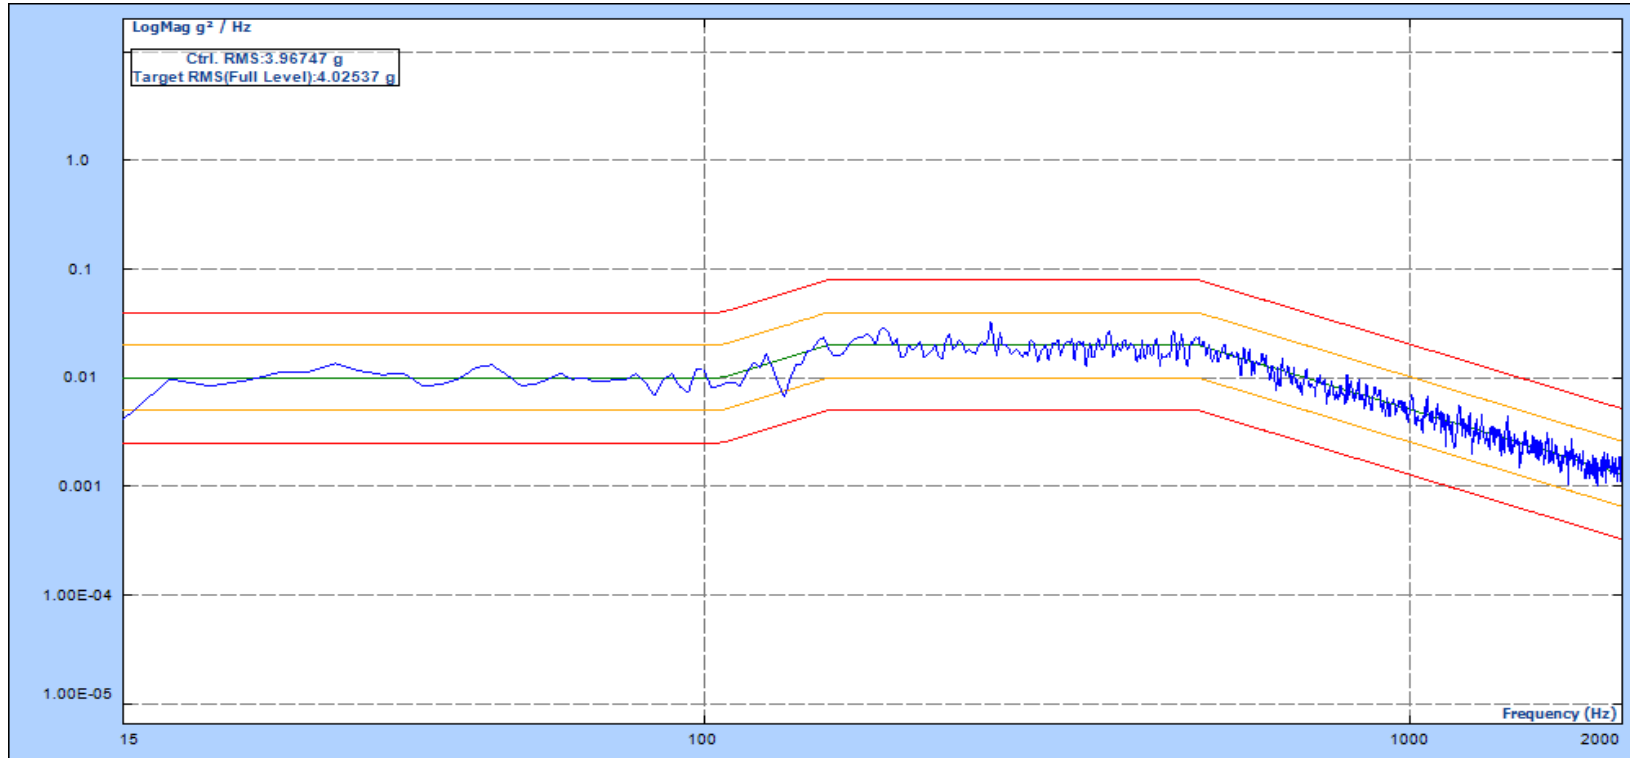
Y axis

Level: 100.00 %  
Velocity Pk: 0.127 m/s  
Remaining: 00:00:00

Drive Pk: 0.922V  
Control RMS: 3.967 g  
Total Elapsed: 01:00:59

Est. Disp. : 1.490 mm Pk-Pk  
Target RMS: 4.020 g  
Full Level Elapsed: 01:00:00

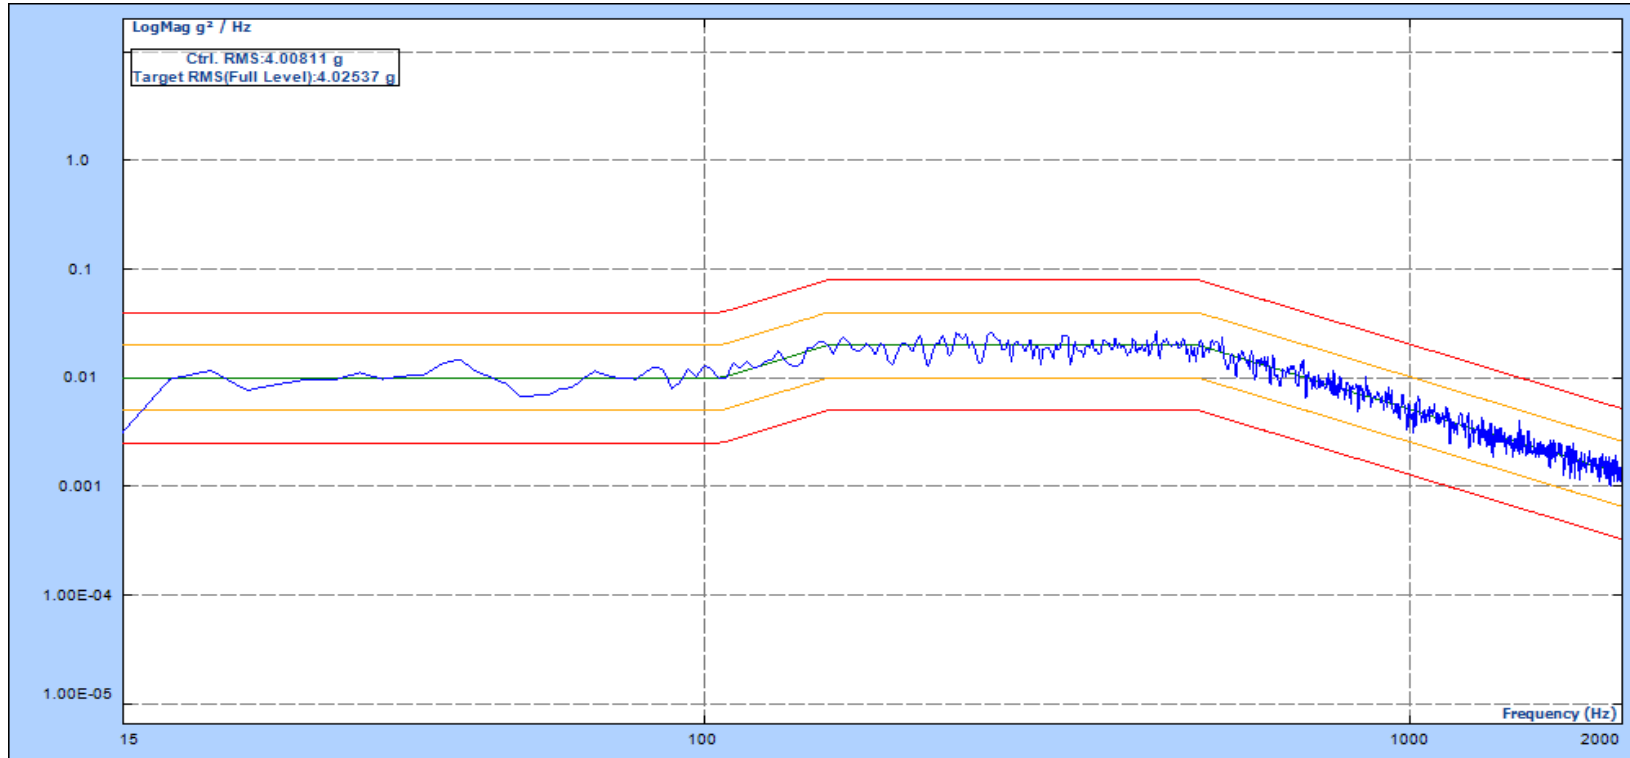
Z axis

Level: 100.00 %  
Velocity Pk: 0.127 m/s  
Remaining: 00:00:00

Drive Pk: 0.990V  
Control RMS: 4.008 g  
Total Elapsed: 01:00:59

Est. Disp. : 1.513 mm Pk-Pk  
Target RMS: 4.020 g  
Full Level Elapsed: 01:00:00
