SM23P-297
Environment Test Report

Test Start : 2017, 09,13
Test End : 2017,10, 11

Ver 1.0

Oct. 11, 2017

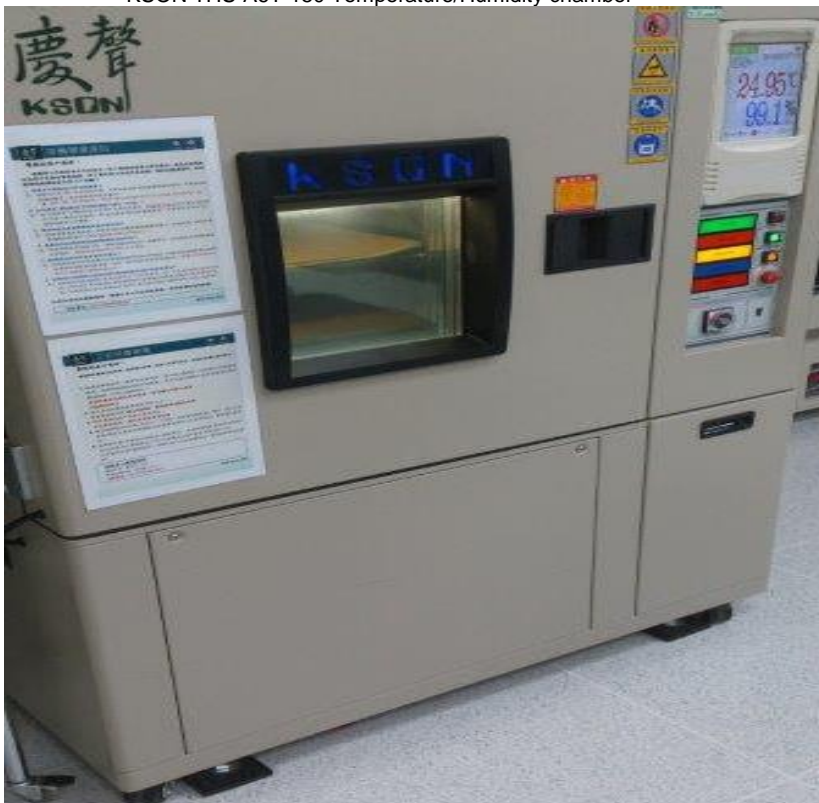
KSON THS-A6T-150 Temperature/Humidity chamber

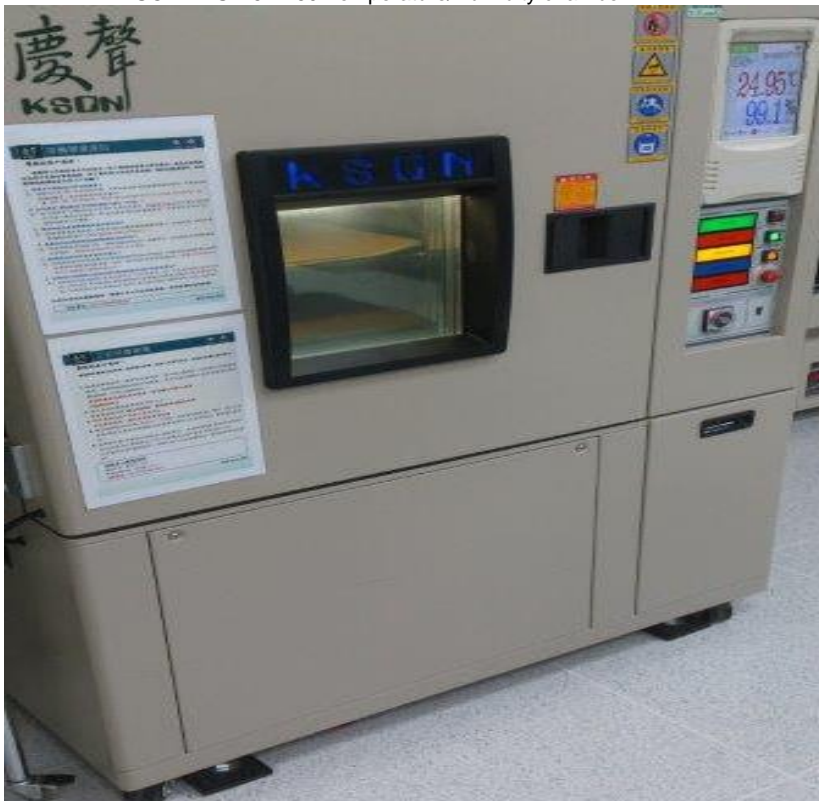
KSON THS-A6T-150 Temperature/Humidity chamber

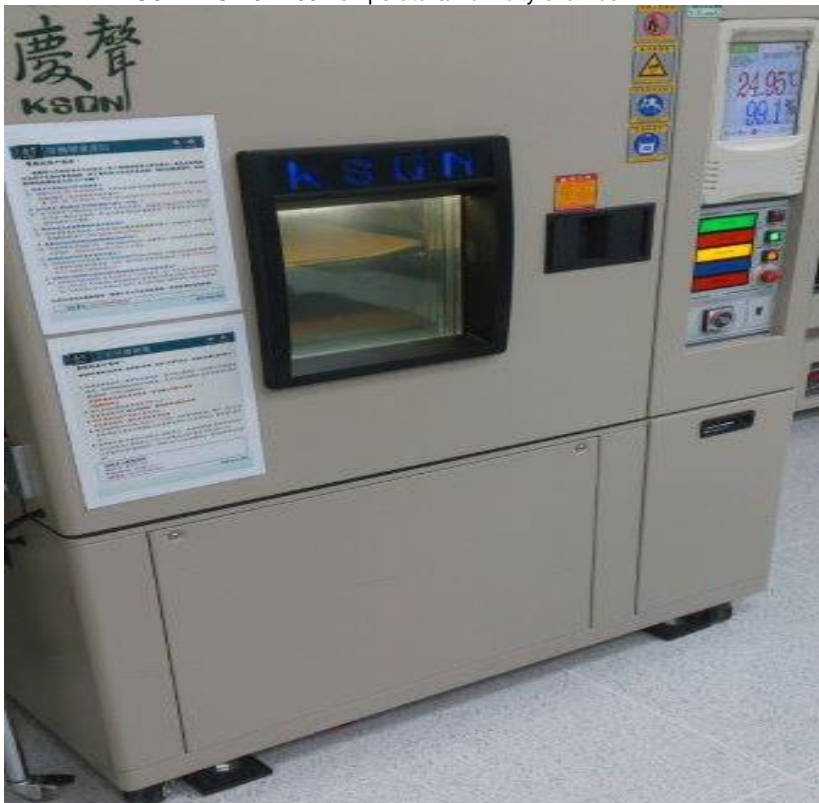
KSON THS-A6T-150 Temperature/Humidity chamber

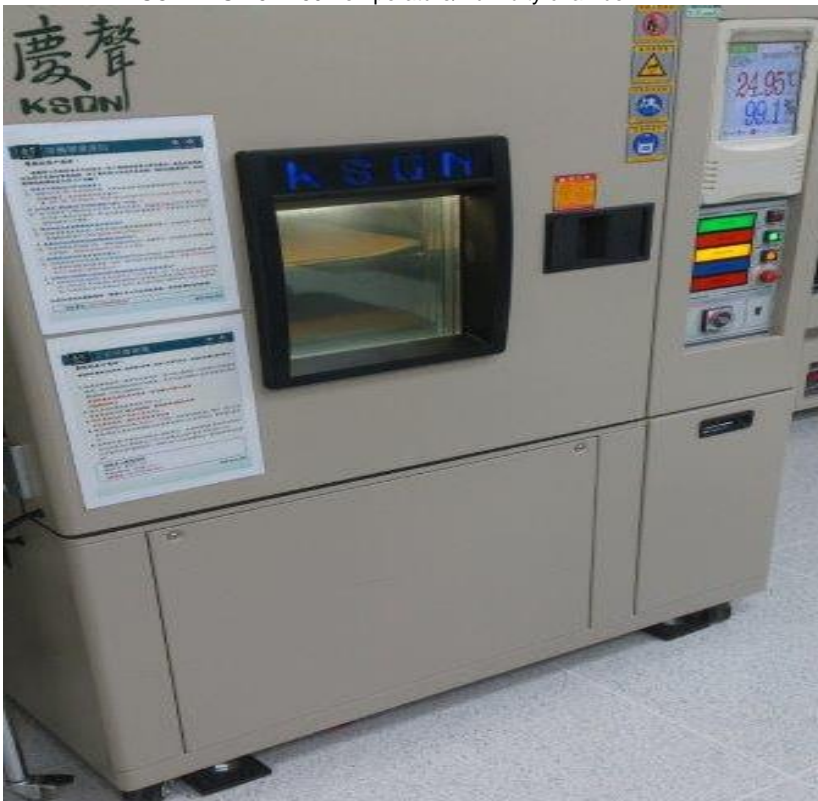
KSON THS-A6T-150 Temperature/Humidity chamber
