FLOWER OF SULFUR TEST REPORT

Customer Company : Apacer Technology Inc
Customer Address : No. 32, Zhongcheng Rd., Tucheng Dist., New Taipei City 236
, Taiwan (R.O.C.)
Laboratory Address : No.10-1, Lixing 1st Rd., East Dist., Hsinchu City 300
, Taiwan (R.O.C.)
Model Name : PX220-M280
Date Received : DEC 20, 2020
Date Tested : DEC 28, 2020 ~ JAN 6, 2021

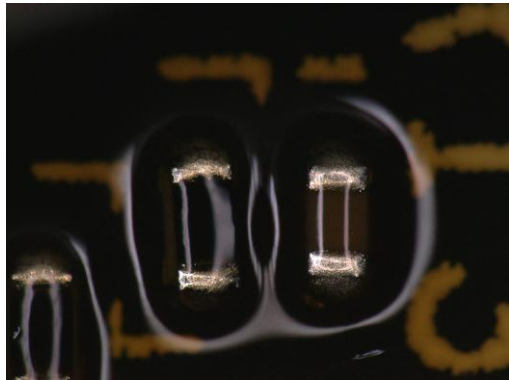
Results	No Corrosion	No Corrosion
