FLOWER OF SULFUR TEST REPORT

Customer Company : Apacer Technology Inc
 Customer Address : No. 32, Zhongcheng Rd., Tucheng Dist., New Taipei City 236
, Taiwan (R.O.C.)
 Laboratory Address : No.10-1, Lixing 1st Rd., East Dist., Hsinchu City 300
, Taiwan (R.O.C.)
 Model Name : SX250-M280
 Date Received : DEC 20, 2020
 Date Tested : DEC 28, 2020 ~ JAN 6, 2021

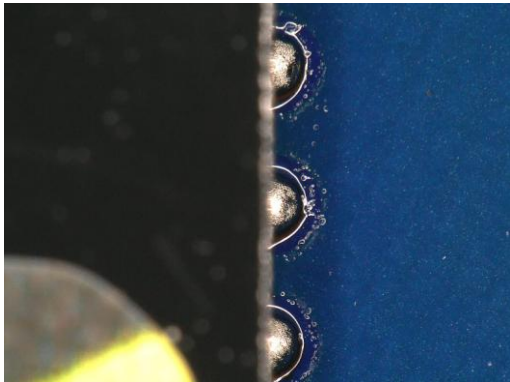
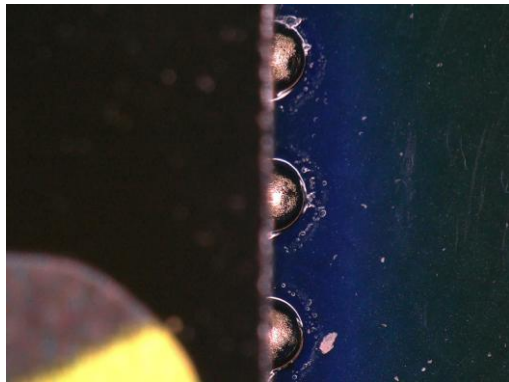
Results	No Corrosion	No Corrosion
TV#01_08

Results	No Corrosion	No Corrosion
TV#01_09

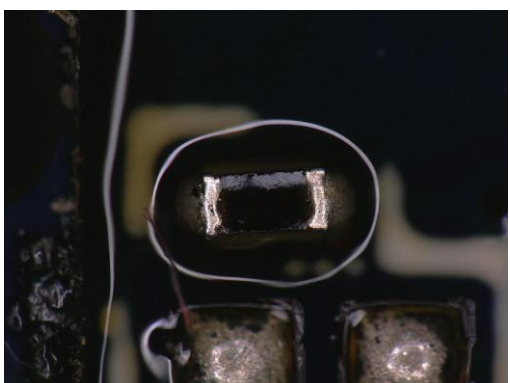
Results	No Corrosion	No Corrosion
TV#02_02

Results	No Corrosion	No Corrosion

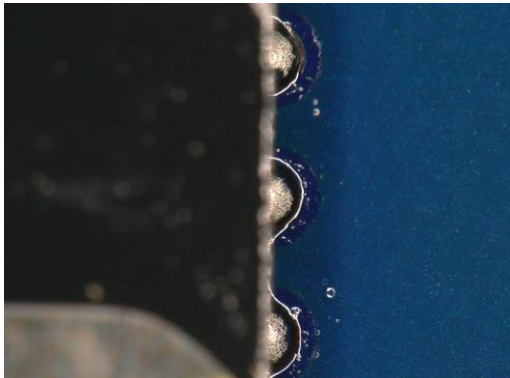
Results	No Corrosion	No Corrosion
TV#07_09
